Pennsy Service Bulletin

Hinge Base Plate Crack

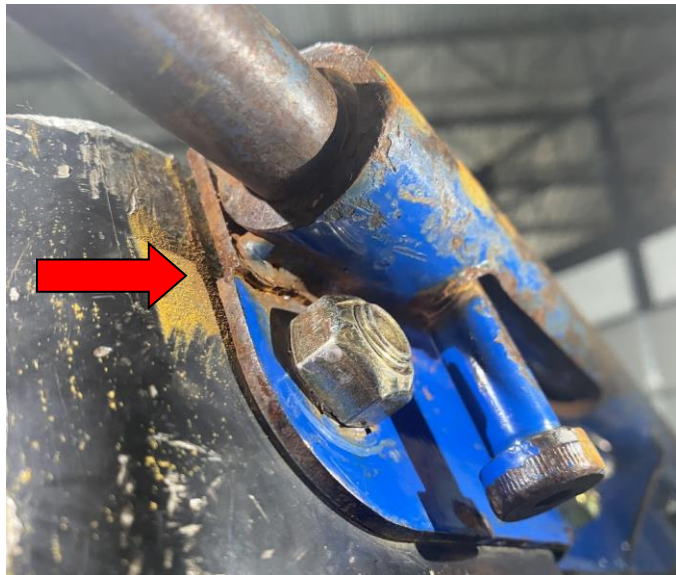
During routine service a crack in the base plate of the hinge may appear. This crack may go unnoticed during standard inspections.

1. During standard inspections, look for cracks near the weld affixing the hinge barrel.
2. Looking from the side of the bridge plate, observe the edge of the hinge base plate.
3. The crack will cause a portion of the hinge base to separate from the aluminum bridge plate.
4. Examine both the stationary-pin and sliding-pin ends of hinge.
5. Imperfections in the weld and damaged paint may visually present as a crack, verify presence of a crack using a pry bar and looking for movement of the crack.

If a crack is present and there is clear separation of the hinge base plate, remove the bridge plate from service and contact Pennsy Corporation. Bridge plate hinges showing no cracks pose no risk of failure and may remain in service.
